NATIONAL TRANSPORTATION SAFETY BOARD

HIGHWAY ACCIDENT REPORT

PROPANE TRUCK COLLISION WITH
BRIDGE COLUMN AND FIRE
WHITE PLAINS, NEW YORK
JULY 27, 1994

**Adopted: November 14, 1995
Notation 6479A**

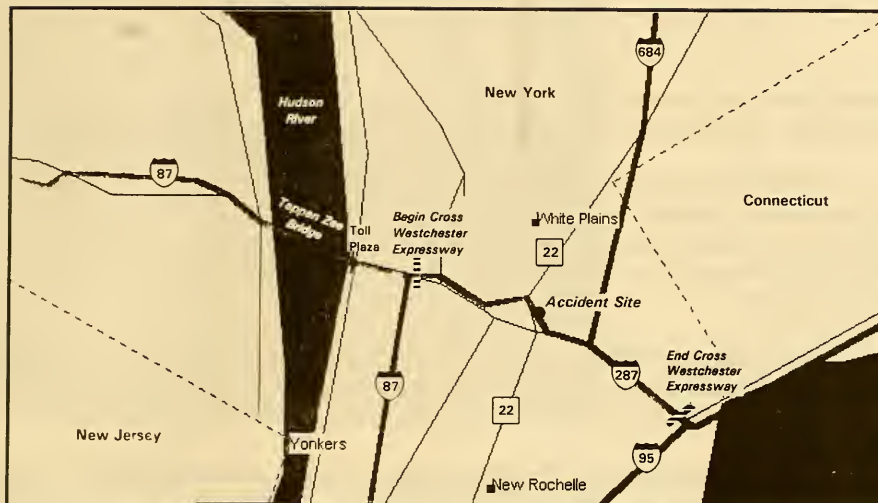
Figure 10.-- I-287/Cross Westchester Expressway

The accident occurred in the eastbound lanes of the Cross Westchester Expressway (I-287) at the Grant Avenue overpass. The six-lane limited-access highway is a major east-west transportation corridor and northern bypass of New York City. It links I-87 (New York State Thruway) to I-95 (New England Thruway). (See figure 10.)

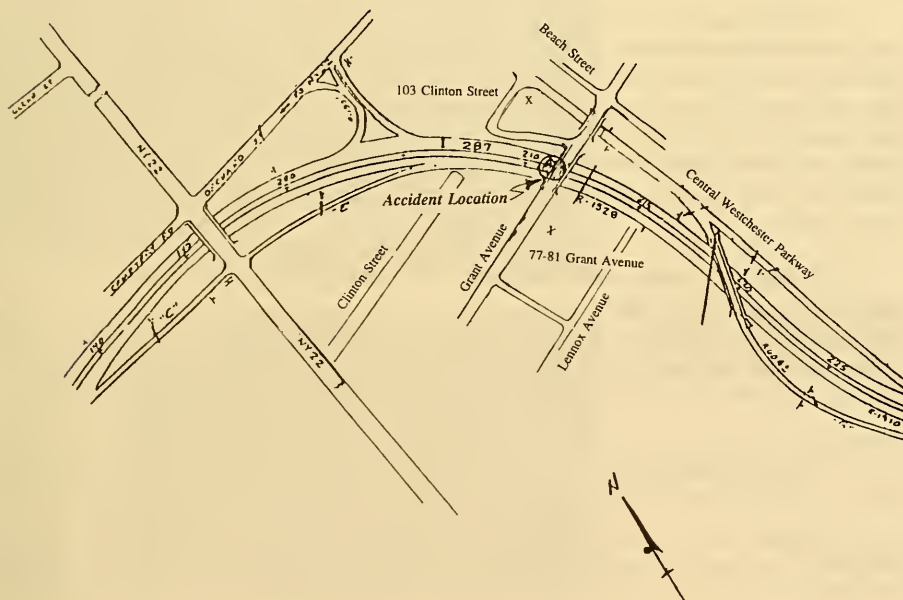
Figure 11. – Plan view of accident site

Highway Description -- The accident occurred on a 1,550-foot-radius (centerline radius) curve to the right on a 2.26-percent downgrade. (See figure 11.) The curve was 2,246 feet long and had 250-foot-long spiral transitions at each end. The centerline of the Grant Avenue bridge was 1,750 feet from the beginning of the curve. The bank or superelevation for the curve was +0.06 (percent). At the accident site the left shoulder slope was approximately -0.02 and the embankment foreslope approximately -0.16.

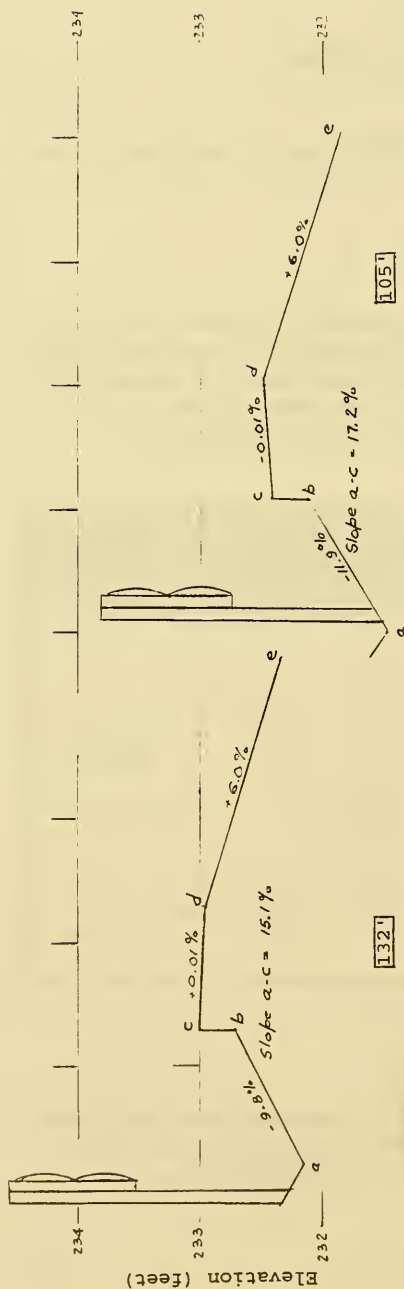
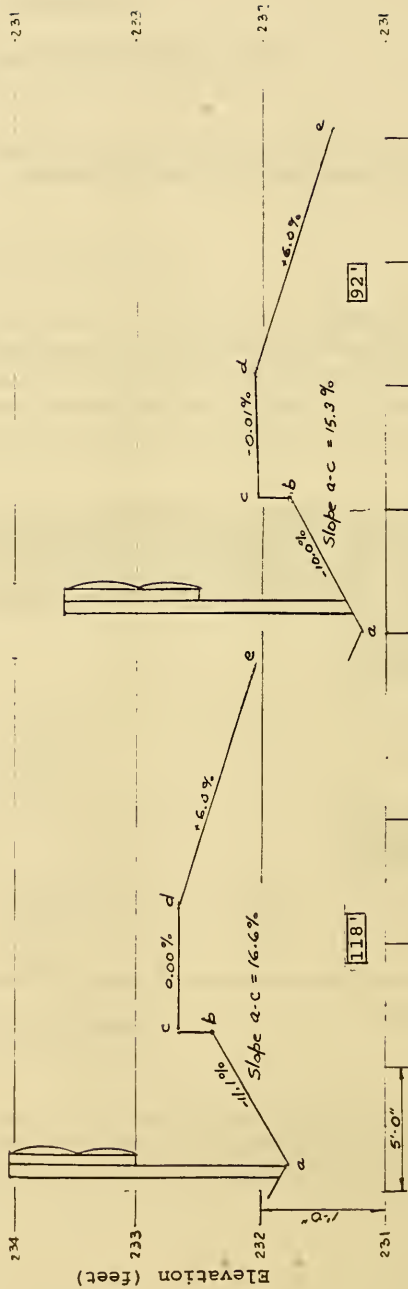
The following four diagrams show the derivation of the superelevation at four different locations on the roadway prior to the accident site. The elevations were determined from the survey made after the accident by CHAS H. SELLS, INC., of Bedford Hills, New York.
